QA-19
Collins' Gift
Church Hill vicinity
Private

INVENTORY FORM FOR STATE HISTORIC SITES SURVEY

Collins' Gift

Orlando Ridout V, Historic Sites Surveyor

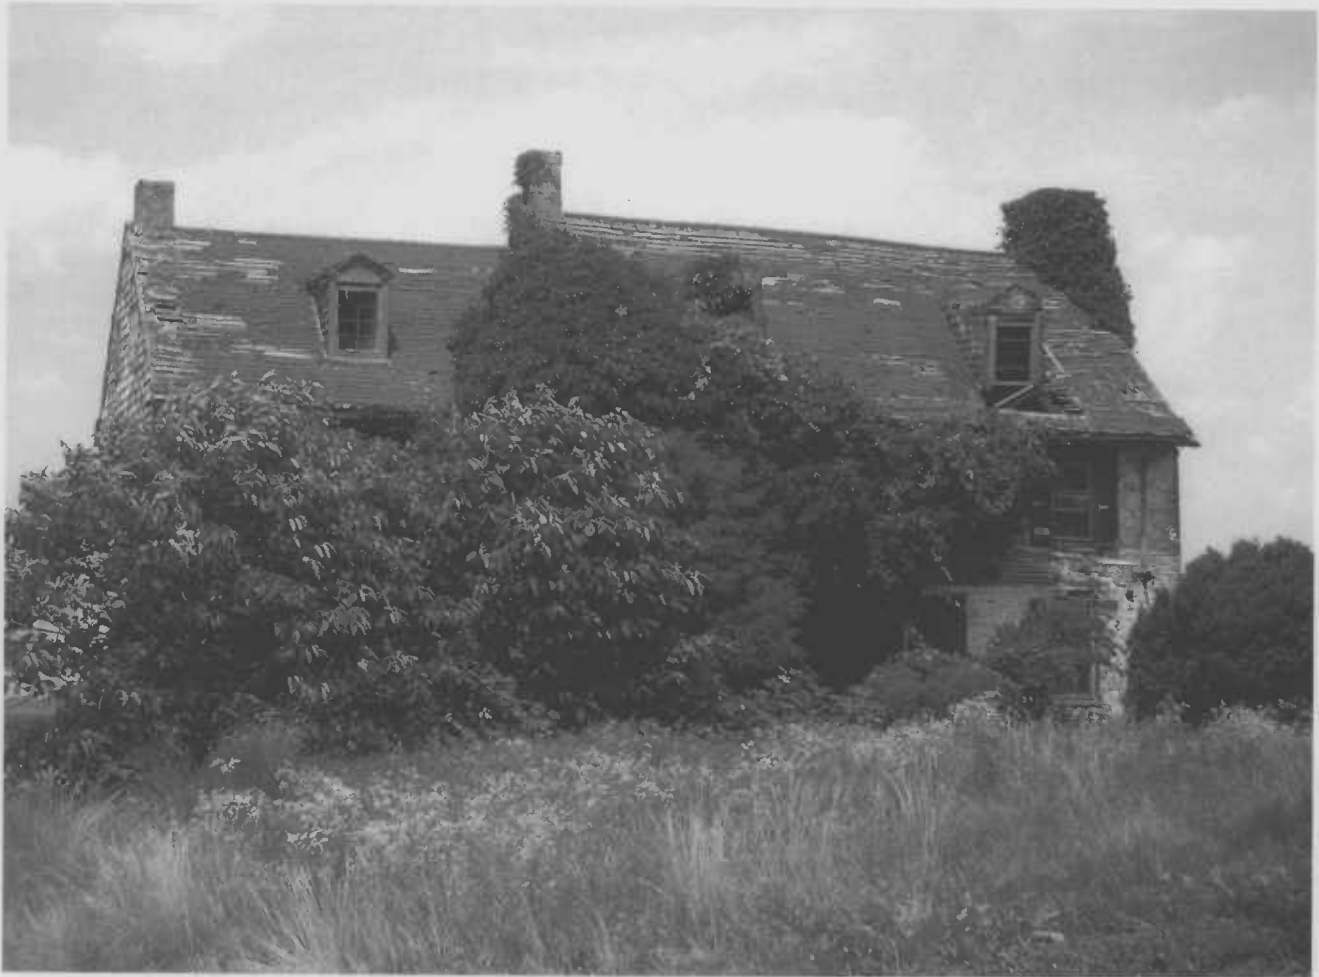
QA-19
Collins' Gift, ruin

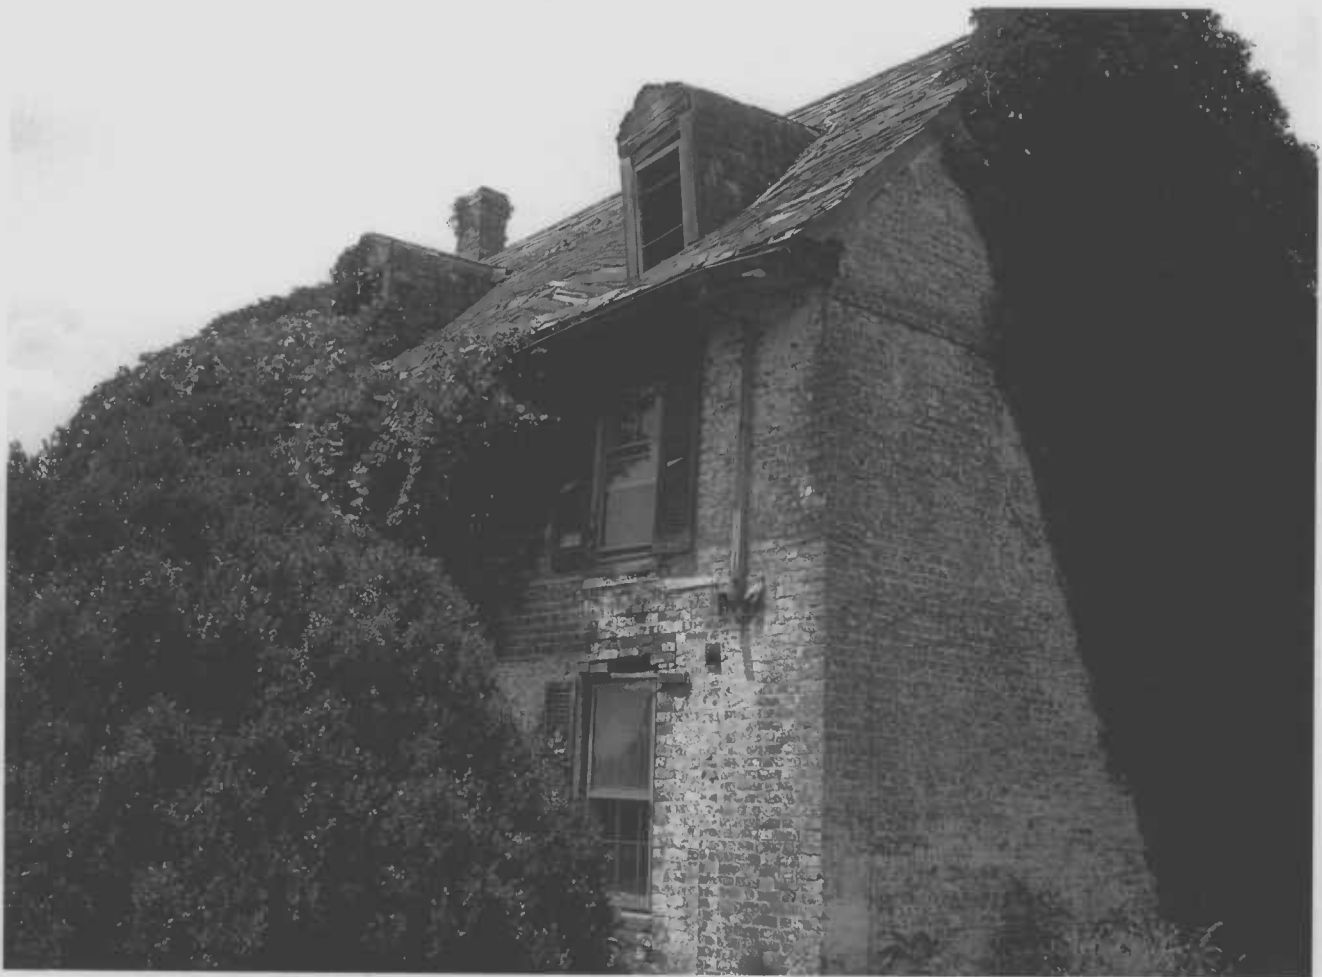
QA-19
collins' Gift, ruin

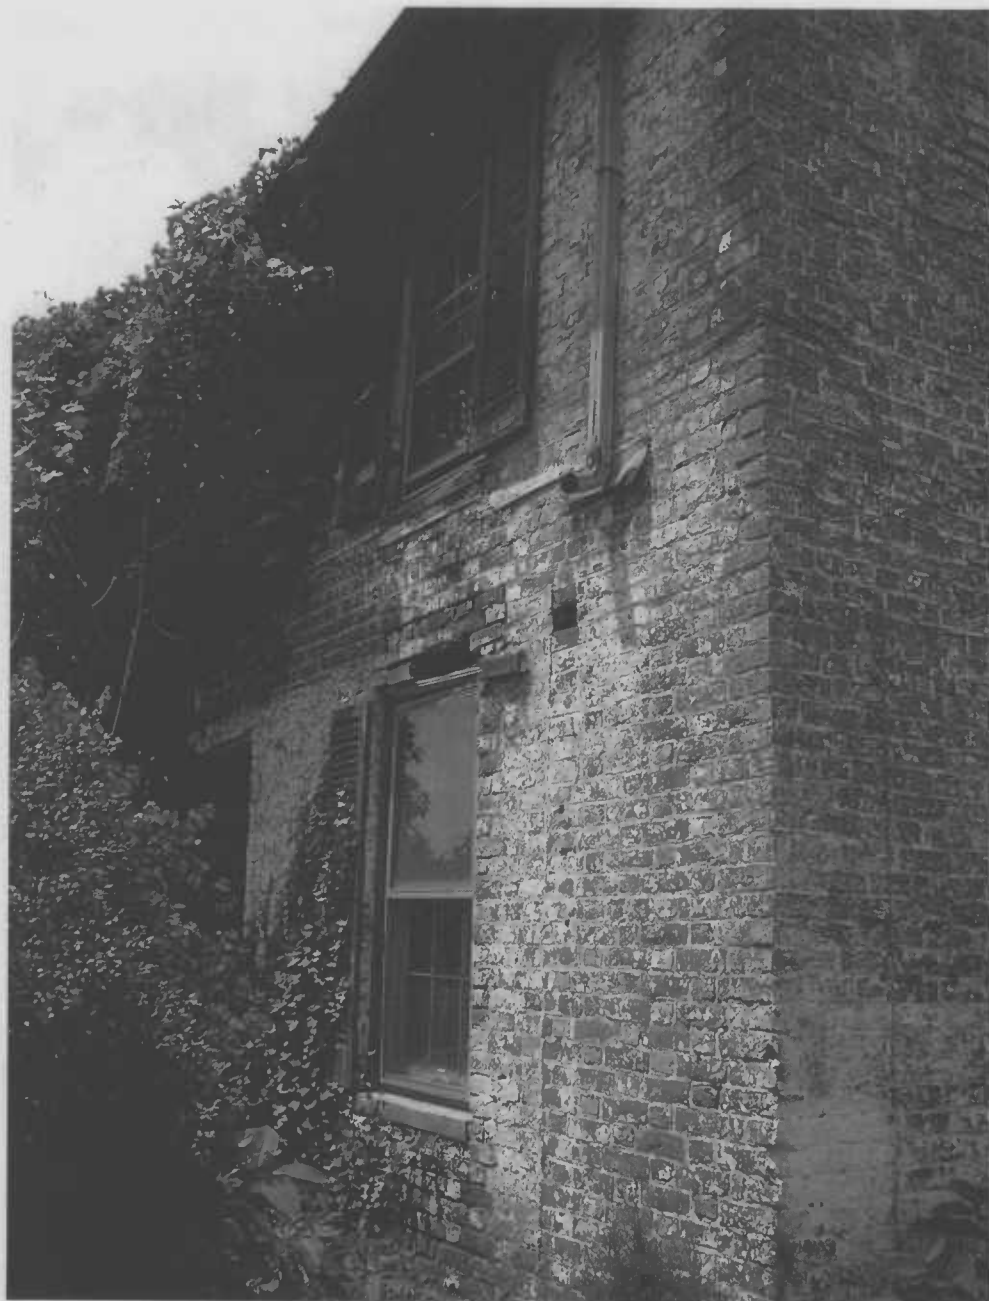
QA-19
Collins' Gift, ruin
